**DOT/FAA/AR-99/20, P1**

# **Development of a Supplemental Inspection Document for the Fairchild SA226 and SA227 Aircraft, Part 1**

Technical Report

14. Sponsoring Agency Code  ACE-100	
15. Supplementary Notes  The FAA William J. Hughes Technical Center manager was Mr. Xiaogong Lee.			
16. Abstract  This report is the first phase of a three-phase program sponsored by the Federal Aviation Administration to develop a supplemental inspection document for Fairchild SA226 and SA227 aircraft. In this report, the mission profiles for the aircraft are established. The principal structural elements are defined, and the operating stresses are established.

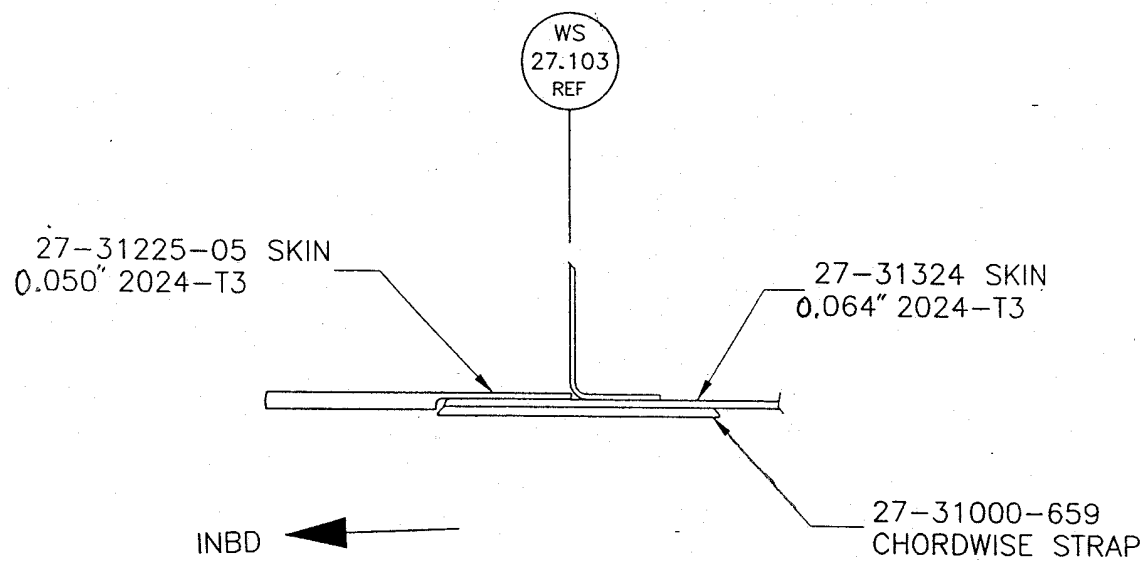
**FIGURE 6-10 W10 - SKIN SPLICE AT W.S. 27.103 LOWER  
SURFACE INBOARD OF SPLICE**

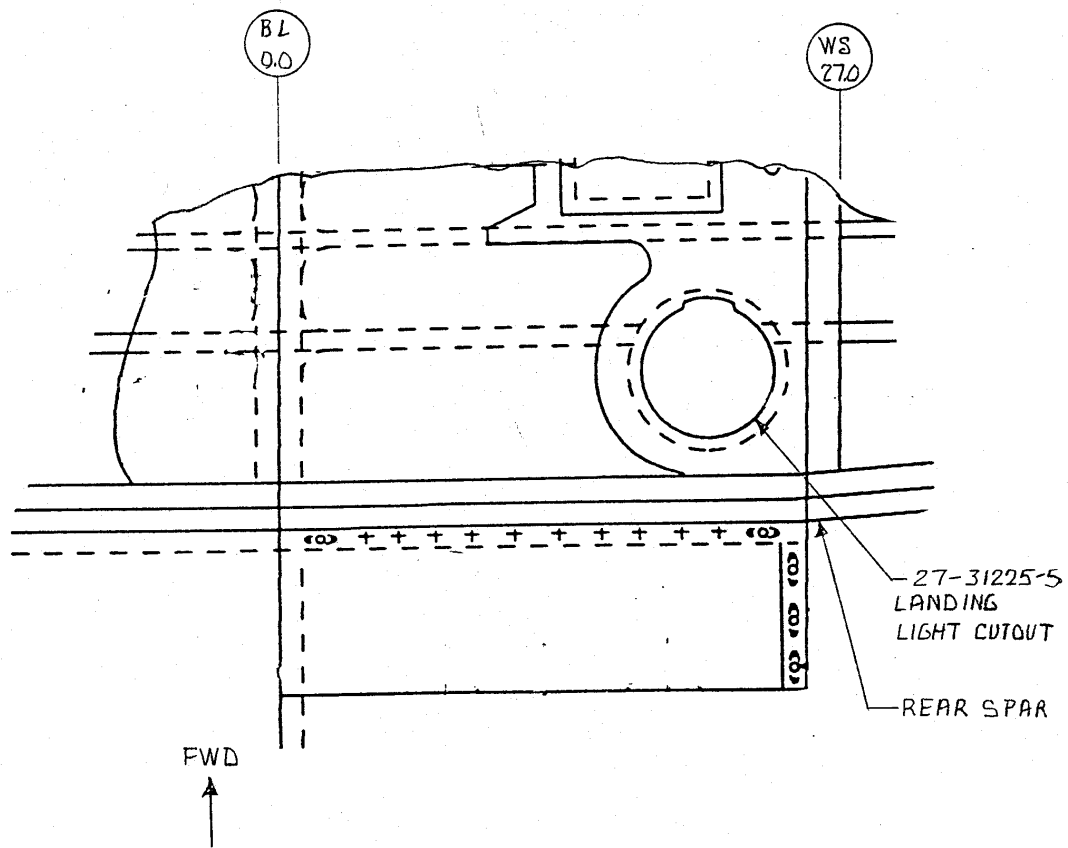
WING LOWER CENTER SECTION SKIN

**FIGURE 6-11 W11 - SA226 WING LOWER CENTER SECTION  
SKIN AT LANDING LIGHT CUTOUT**

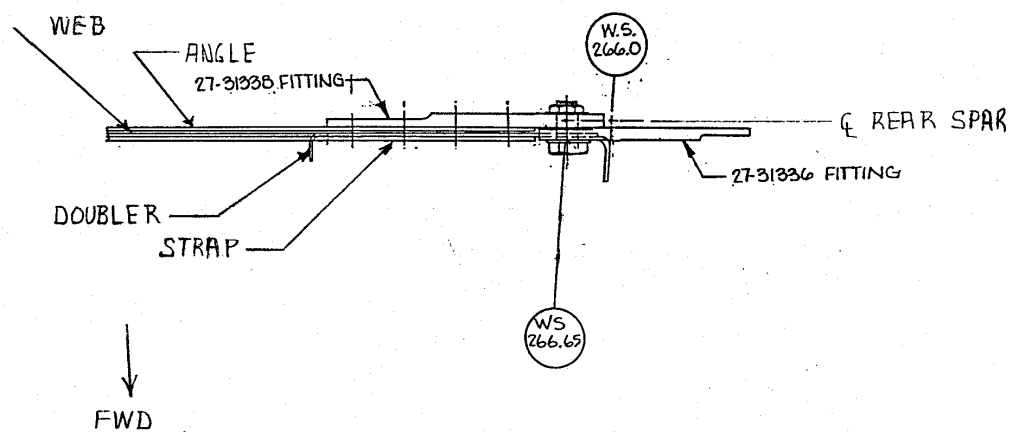
WING TIP EXTENSION FITTING  
 LOWER SURFACE  
 (SKIN NOT SHOWN)

**FIGURE 6-12 W12 - SA227 TIP EXTENSION FITTING REAR  
 SPAR LOWER SURFACE (27-31335)**

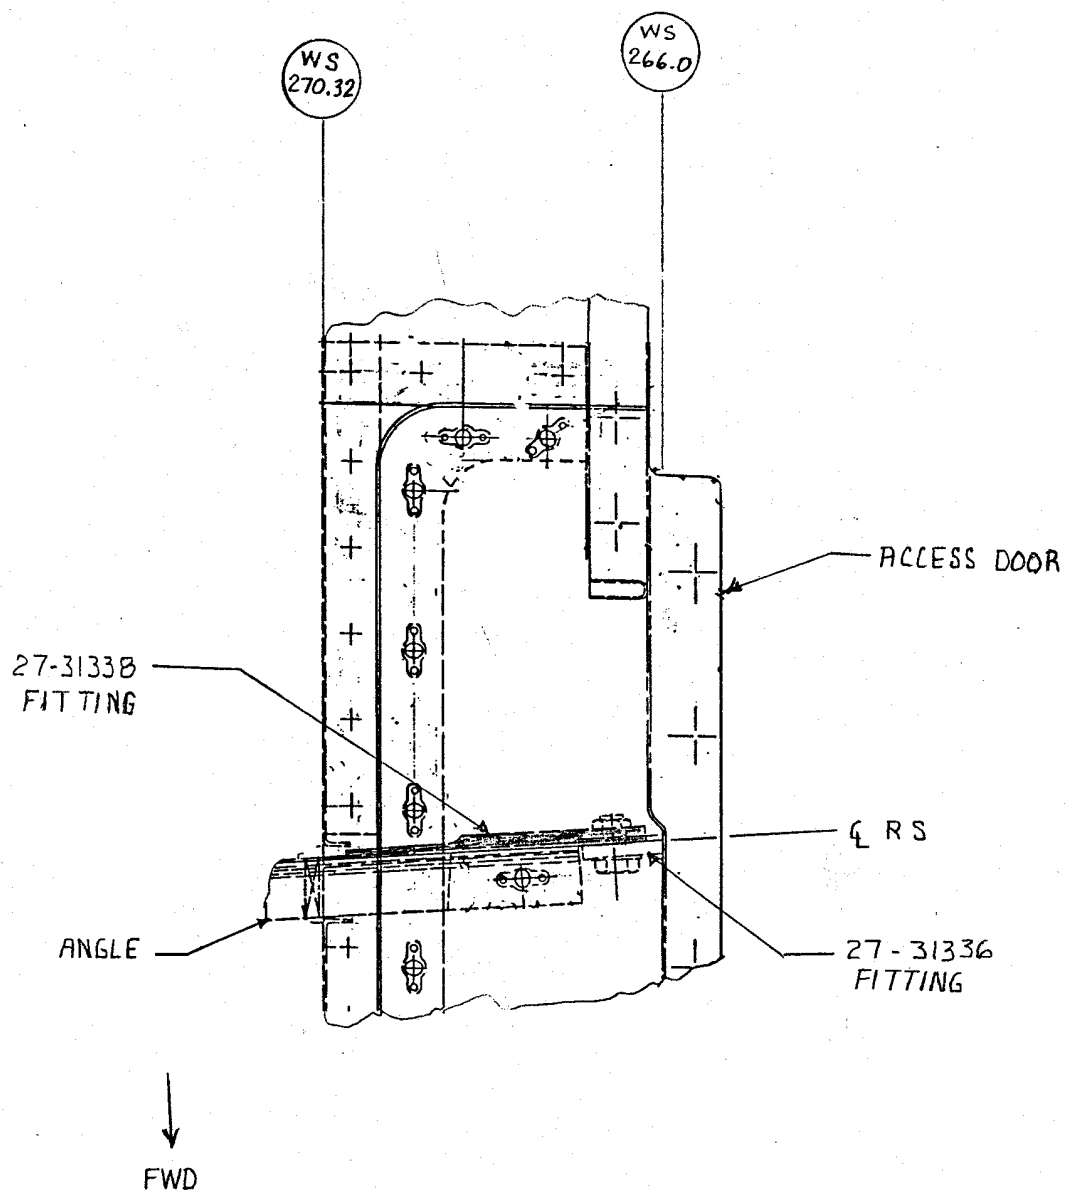
TIP EXTENSION AT END OF OUTBOARD  
FITTING REAR SPAR LOWER SURFACE  
(SKIN NOT SHOWN)

**FIGURE 6-13 W13 - SA227 TIP EXTENSION AT END OF  
OUTBOARD FITTING (REAR SPAR)**

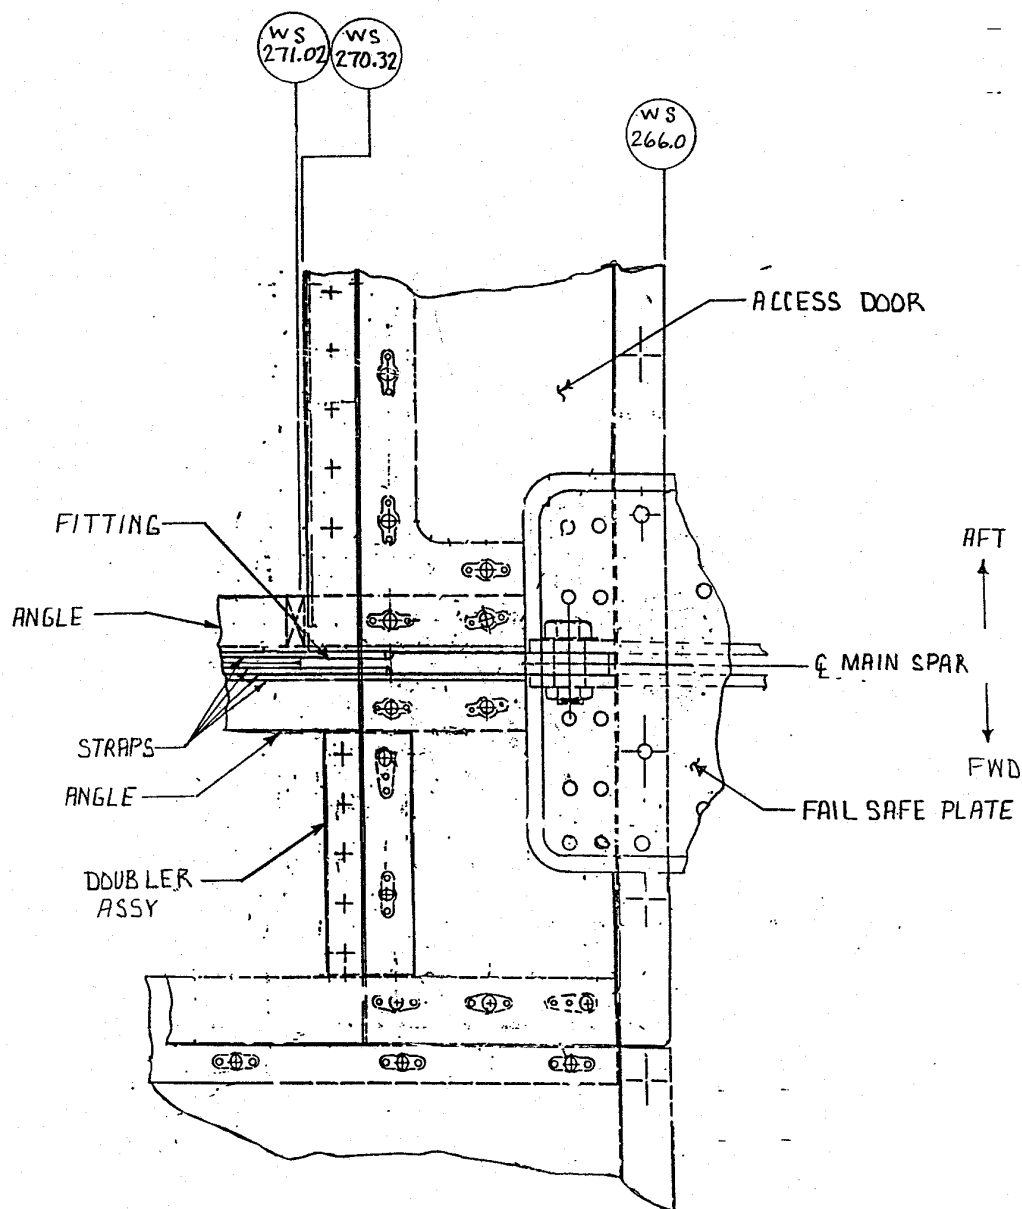
WING TIP EXTENSION AT END OF  
OUTBOARD FITTING MAIN SPAR  
LOOKING UP LOWER SURFACE  
(SKIN NOT SHOWN)

**FIGURE 6-14 W14 - SA227 TIP EXTENSION AT END OF  
OUTBOARD FITTING (MAIN SPAR)**

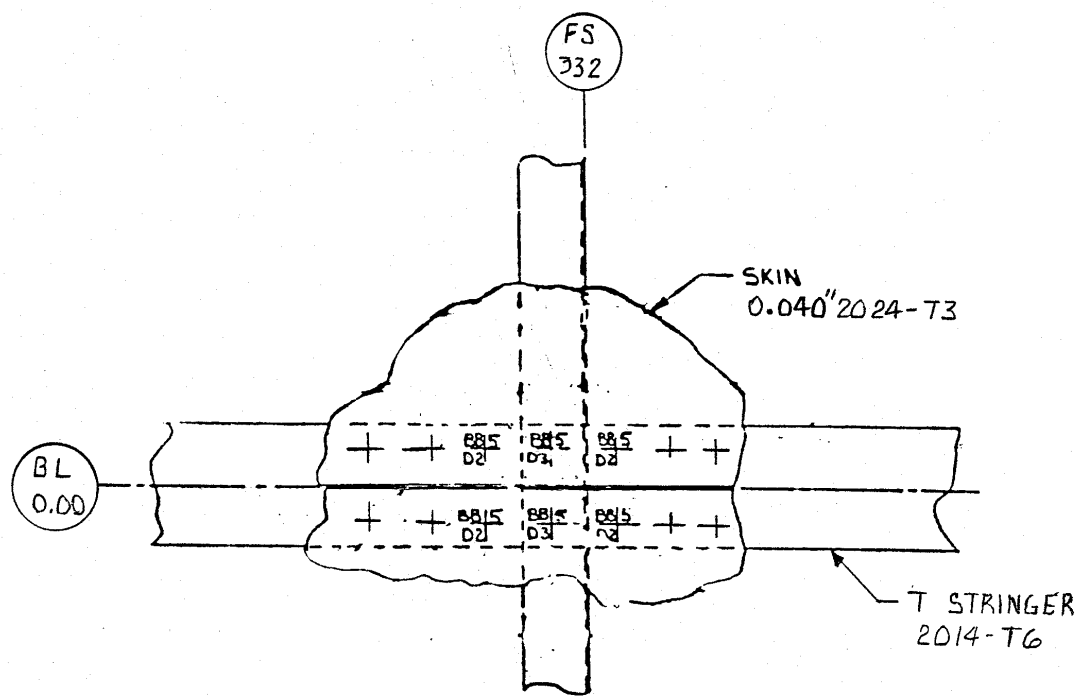
T STRINGER TOP CENTERLINE  
NEAR FS 330

**FIGURE 6-15 F1 - SA226 T STRINGER, TOP CENTERLINE  
NEAR F.S. 330**

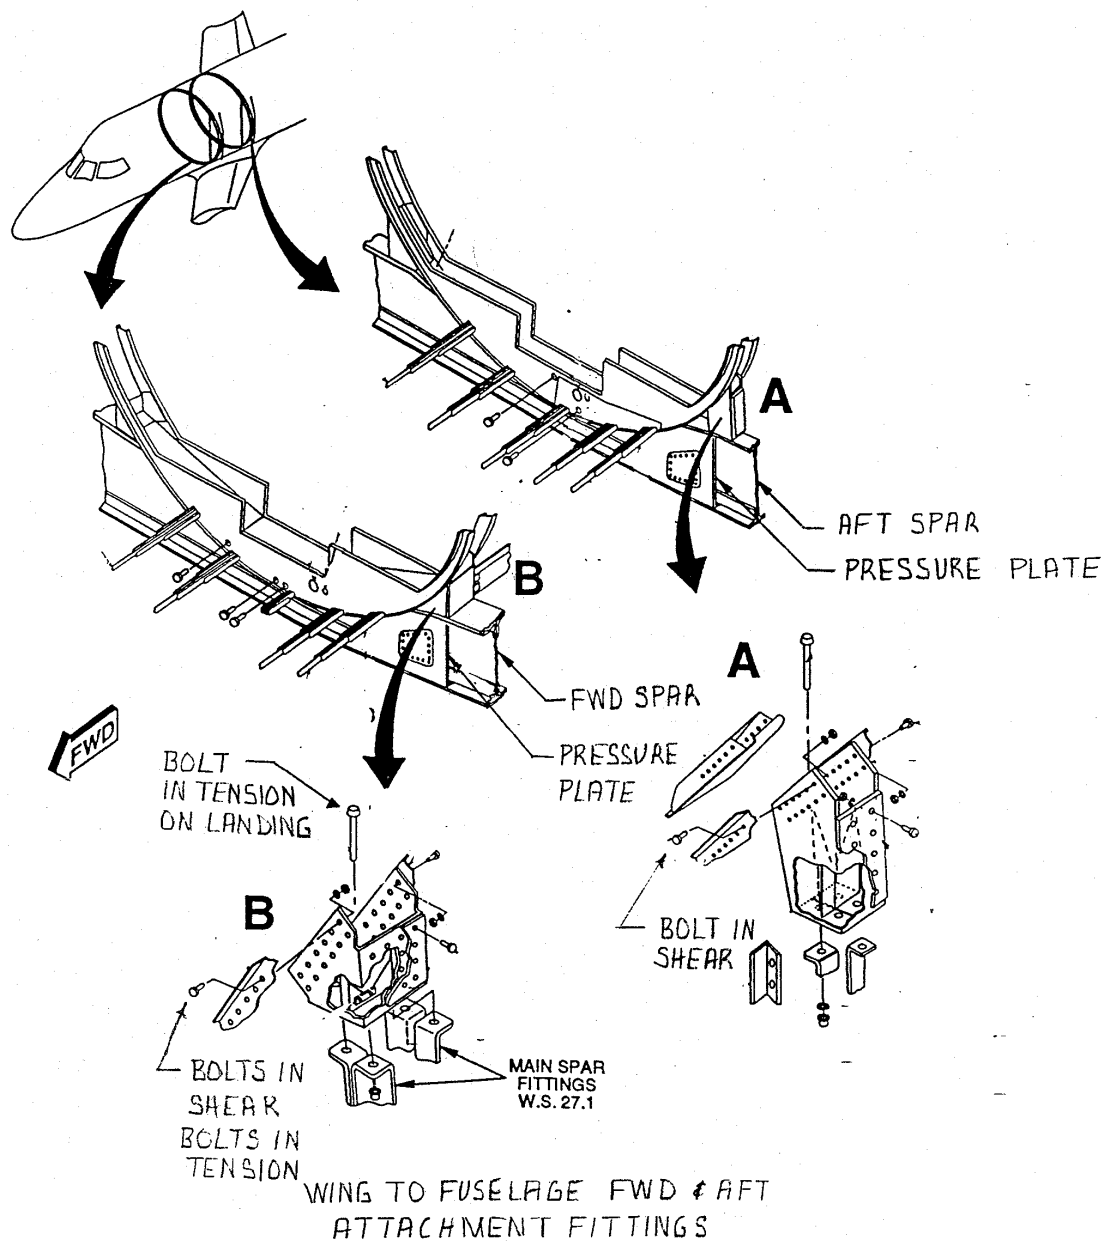
**FIGURE 6-16 F2 AND F3 - SA226 AND SA227 WING FUSELAGE FORWARD ATTACHMENT FITTINGS**

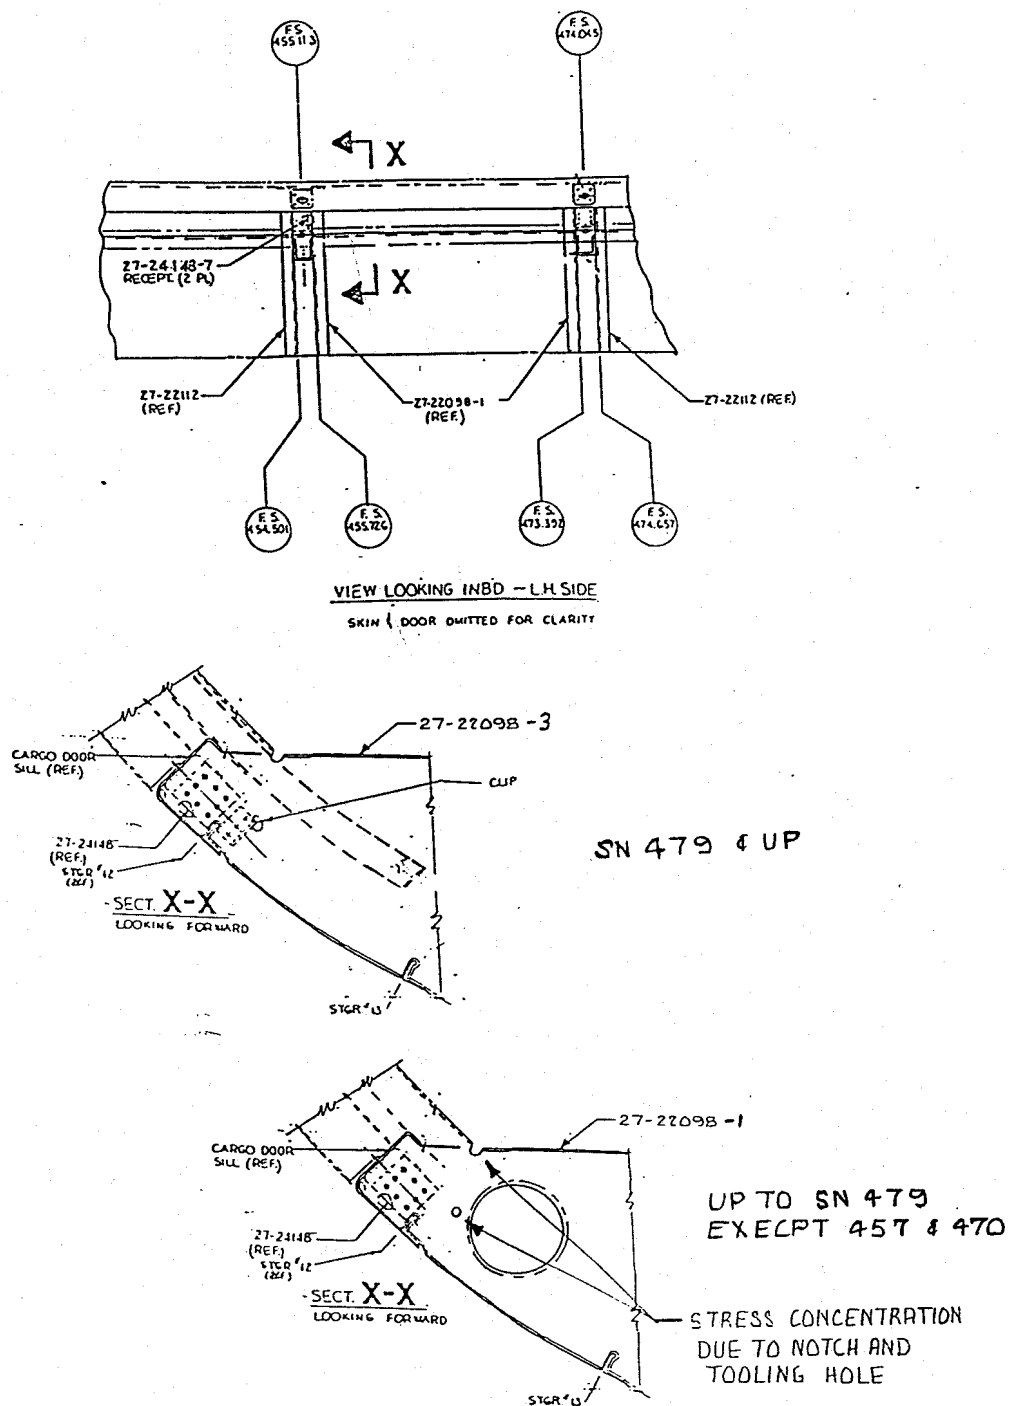
**FIGURE 6-17 F4 - SA226 AND SA227 FUSELAGE FRAME AT FORWARD CARGO DOOR LATCH**

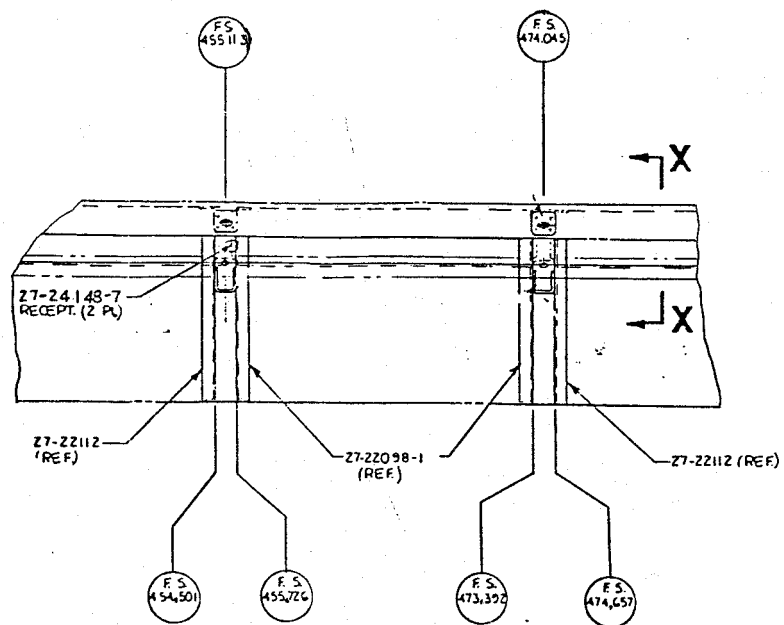
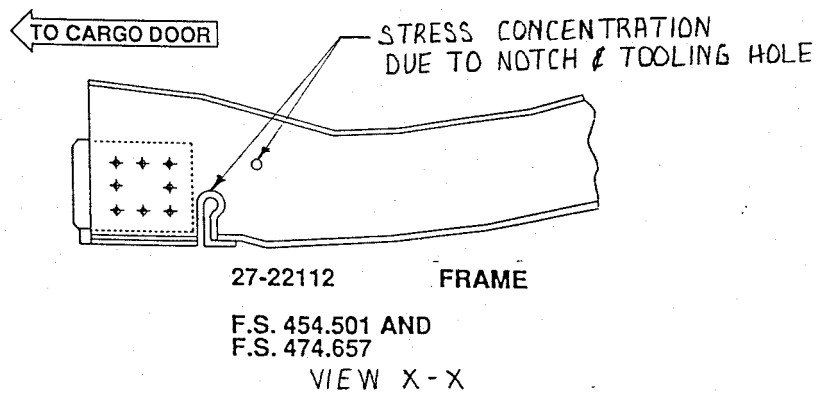
**FIGURE 6-18 F5 – SA226 AND SA227 FUSELAGE FRAME AT CARGO DOOR LATCH**

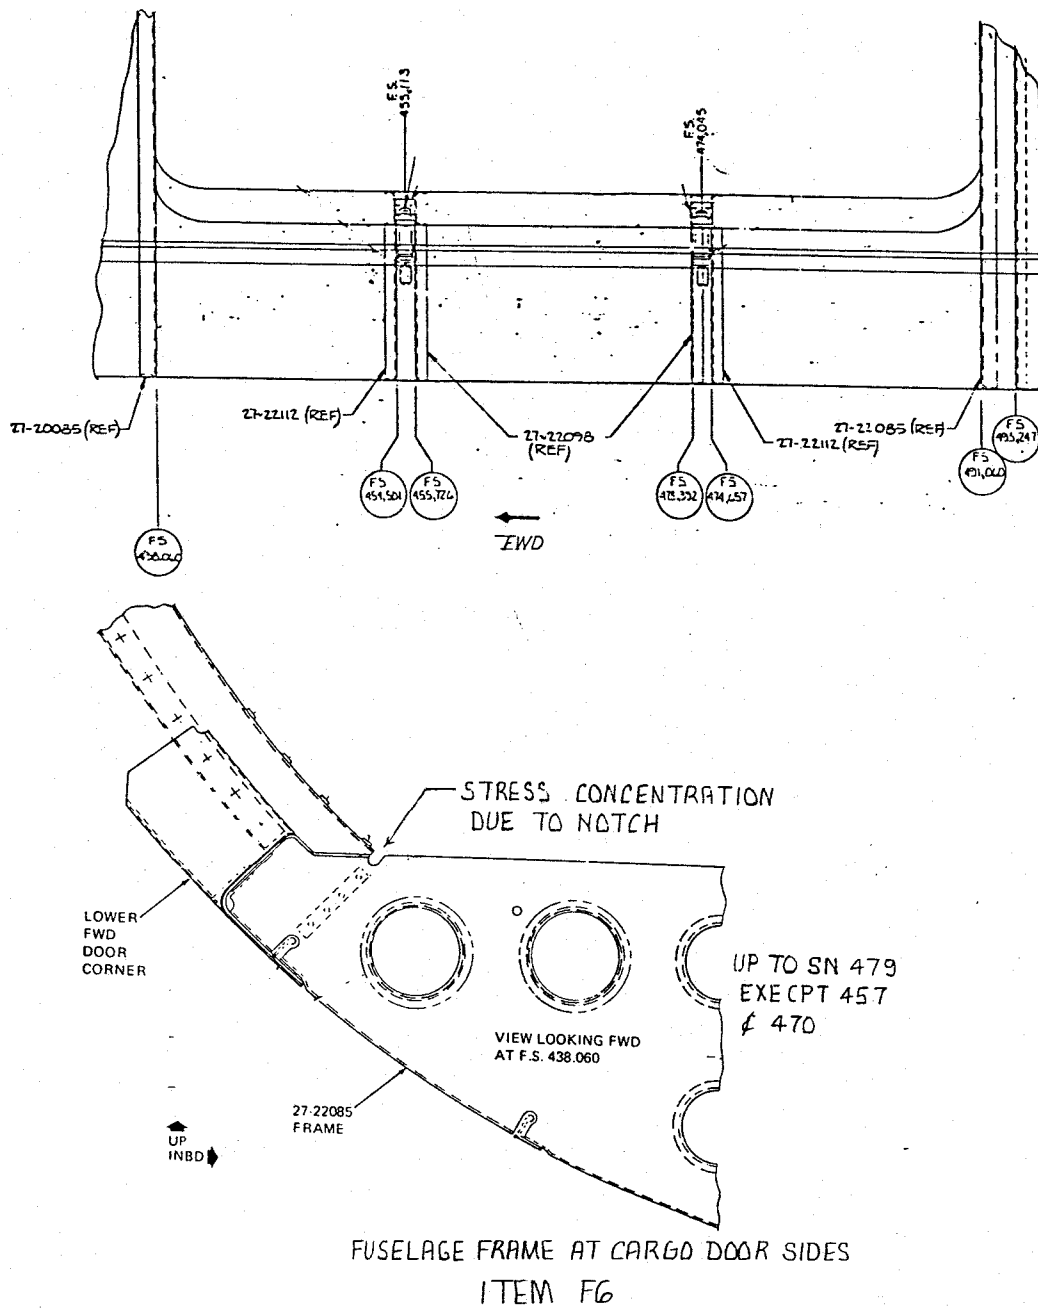
**FIGURE 6-19 F6 - SA226 AND SA227 FUSELAGE FRAME AT CARGO DOOR SIDES**

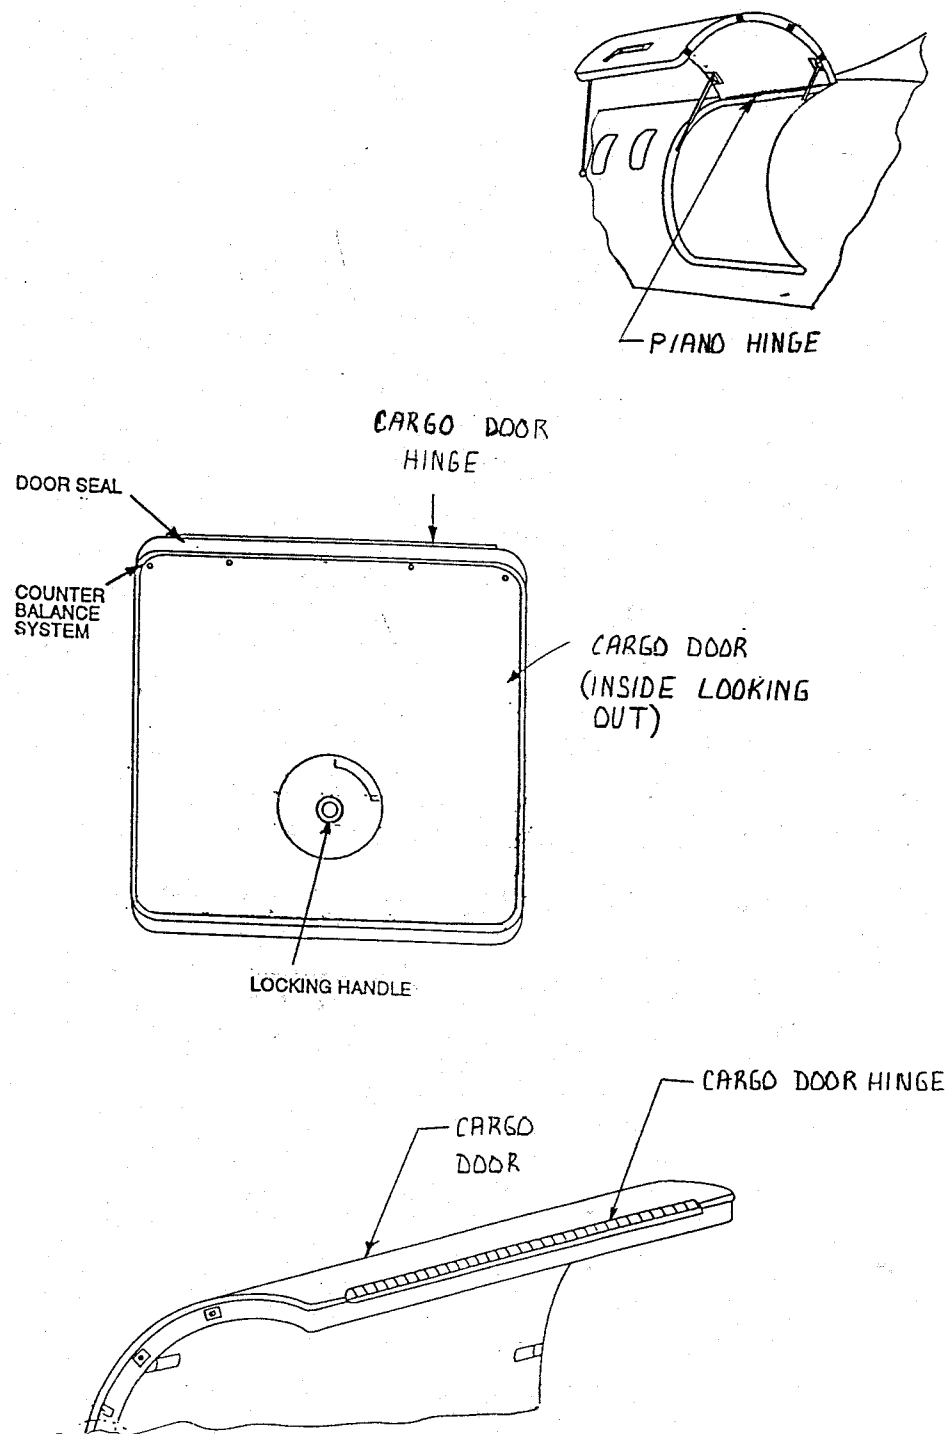
**FIGURE 6-20 F7 - SA226 AND SA227 CARGO DOOR HINGE**

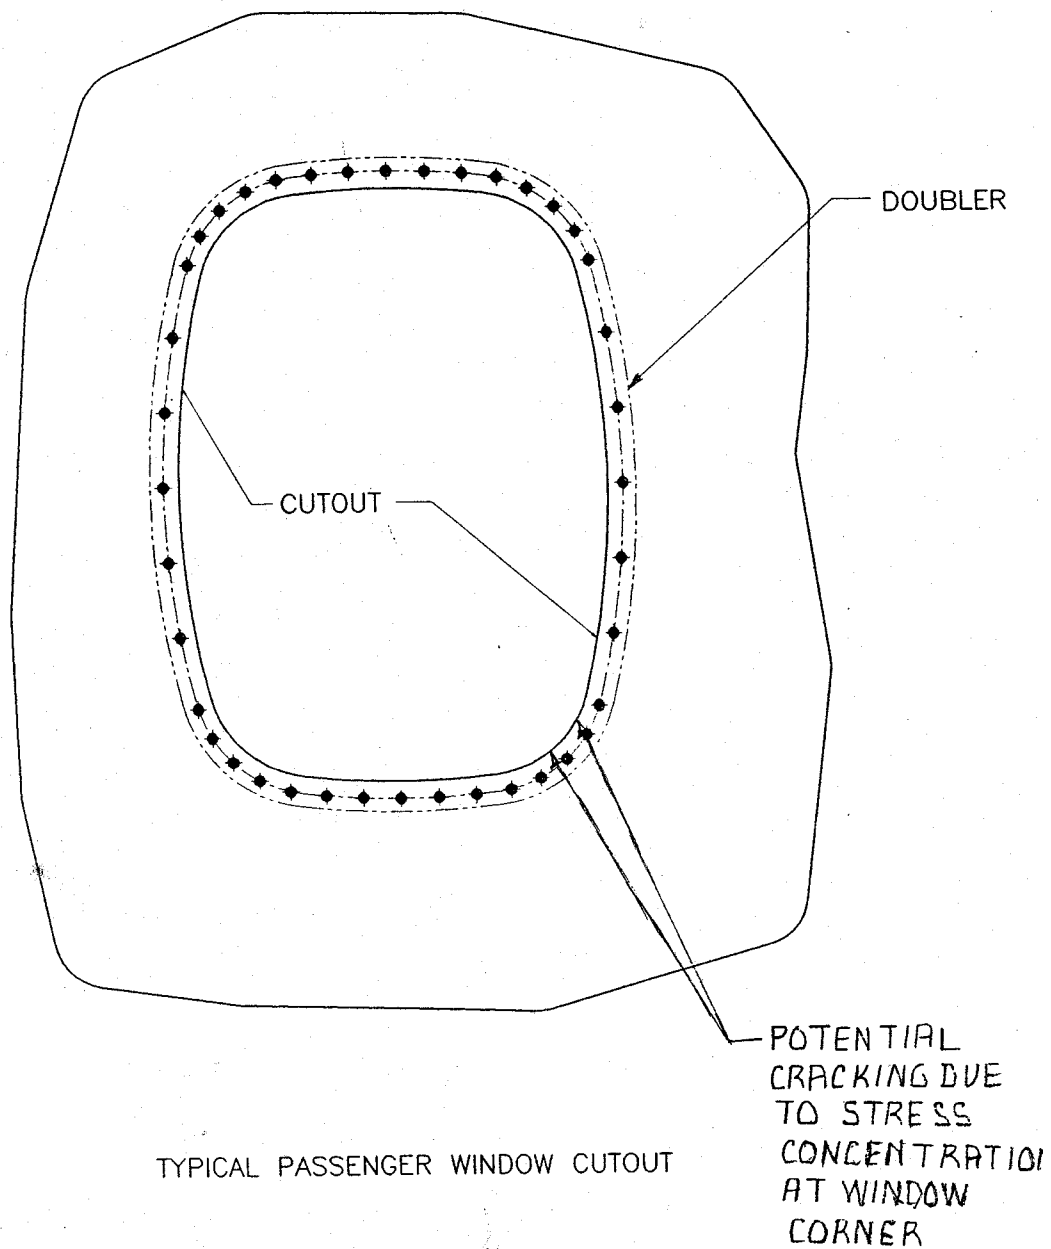
**FIGURE 6-21 F8 - SA226 AND SA227 CORNERS OF PASSENGER WINDOW CUTOUTS**

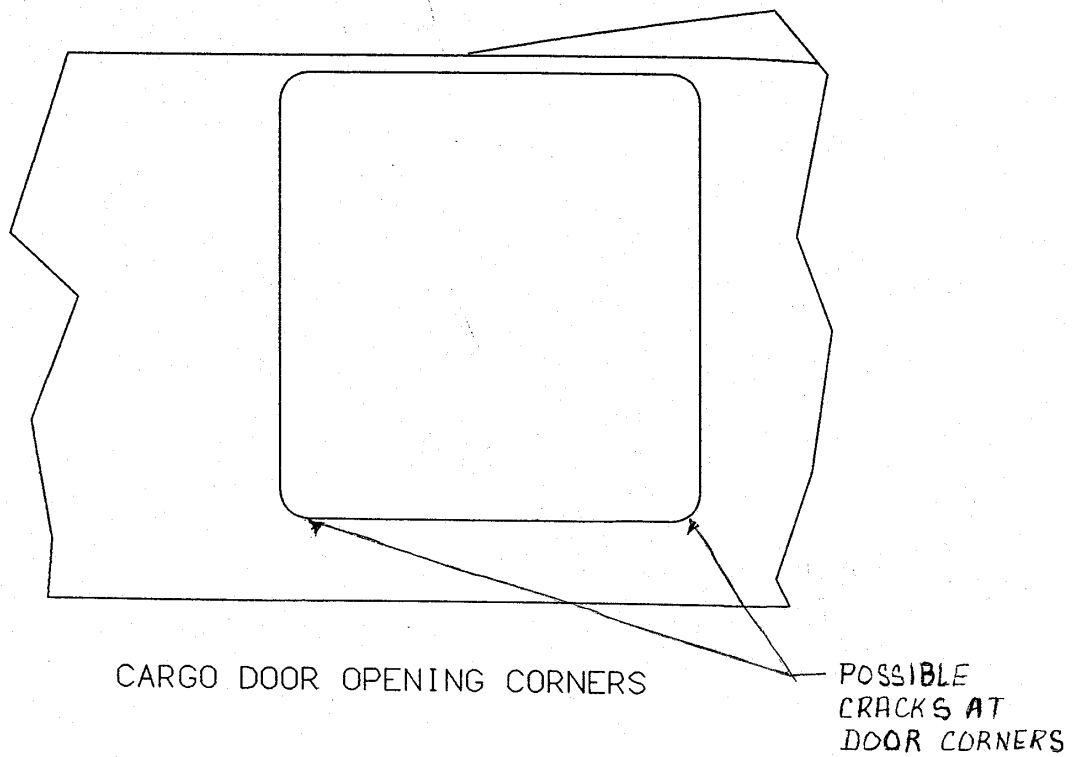
**FIGURE 6-23 F10 - SA226 AND SA227 CARGO DOOR OPENING CORNERS**

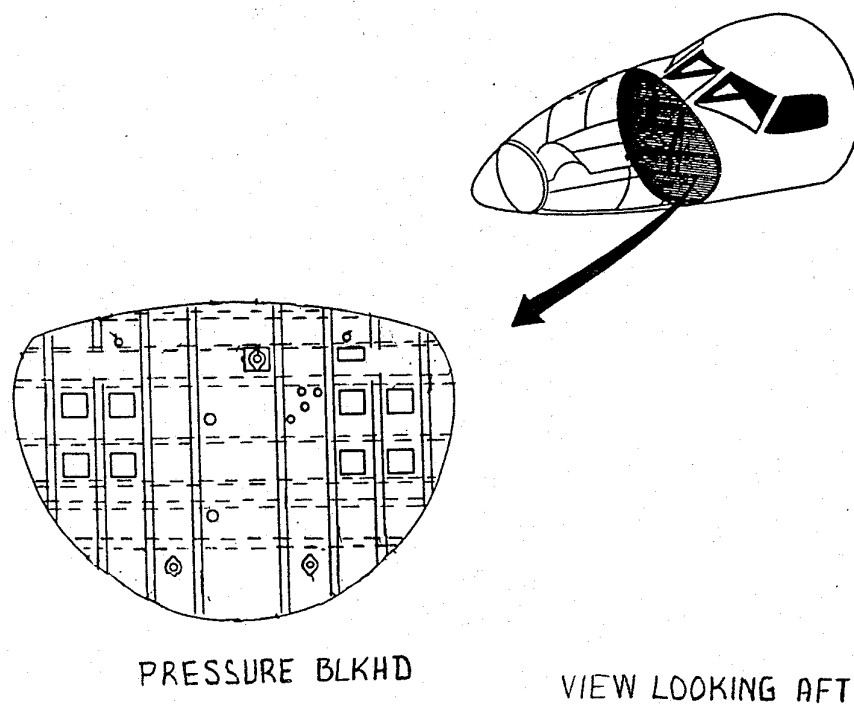
Nose Section, Bulkhead - F.S.69.31

**FIGURE 6-24 F11 - SA226 AND SA227 FORWARD PRESSURE BULKHEAD**

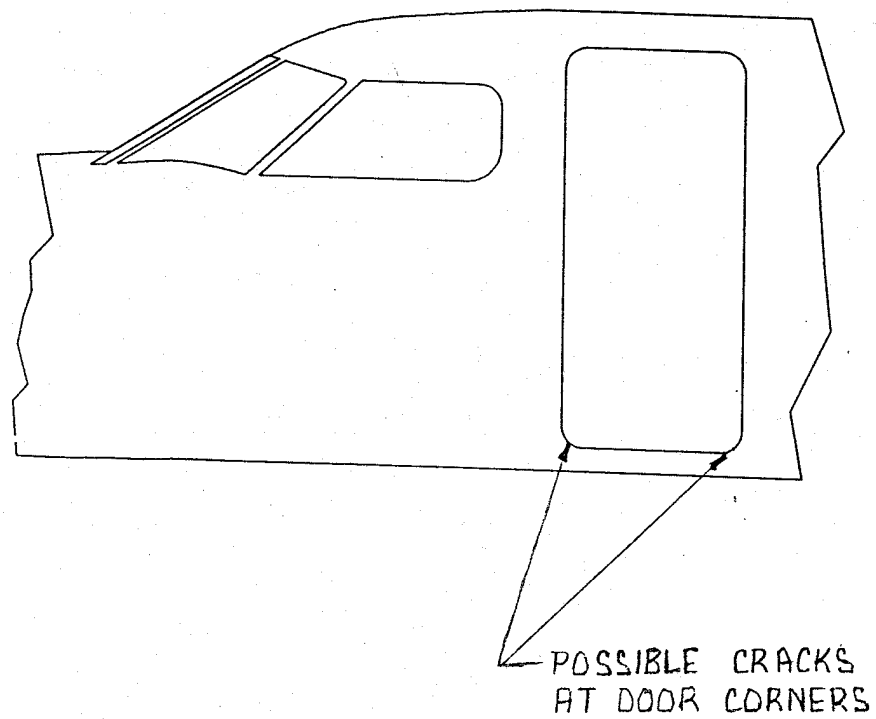
**FIGURE 6-25 F12 - SA226 AND SA227 PASSENGER DOOR  
OPENING CORNERS**

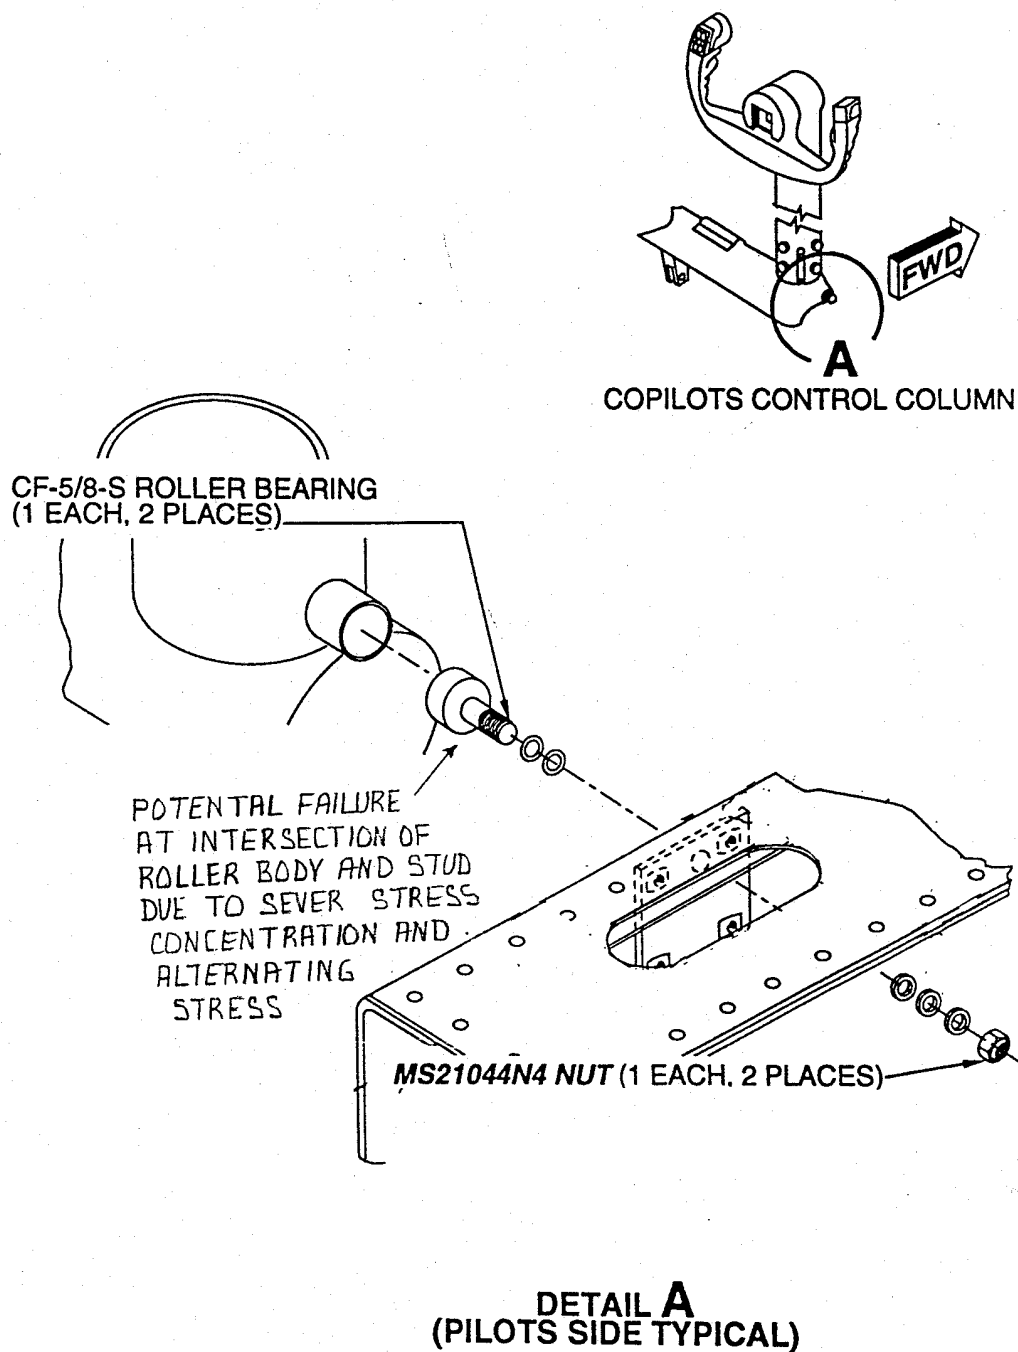
**FIGURE 6-26 F13 - SA226 AND SA227 CONTROL COLUMN  
ROLLER BEARING**

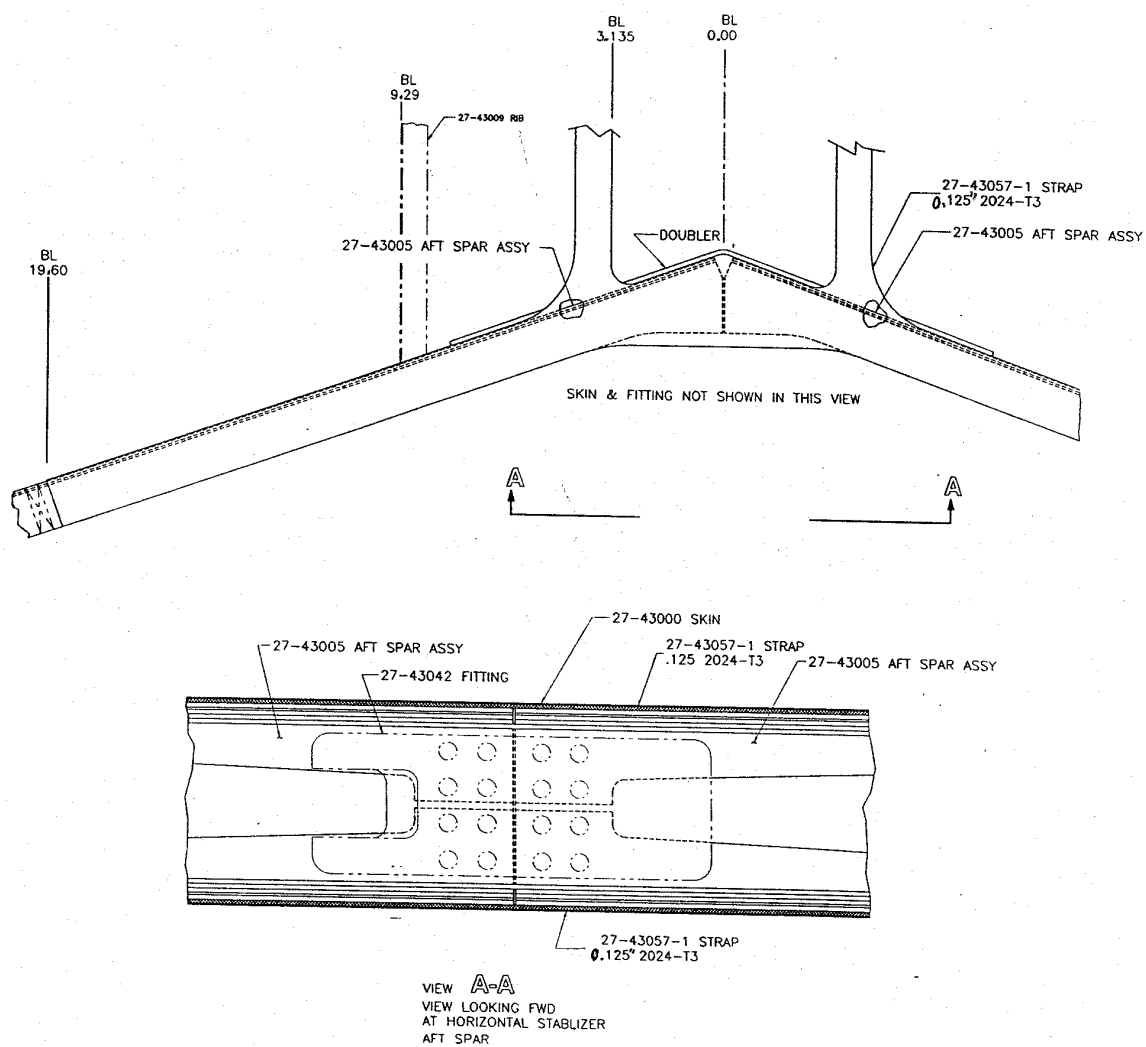
**FIGURE 6-27 H1 - SA226 AND SA227 HORIZONTAL STABILIZER  
RIB STRAP AT REAR SPAR**

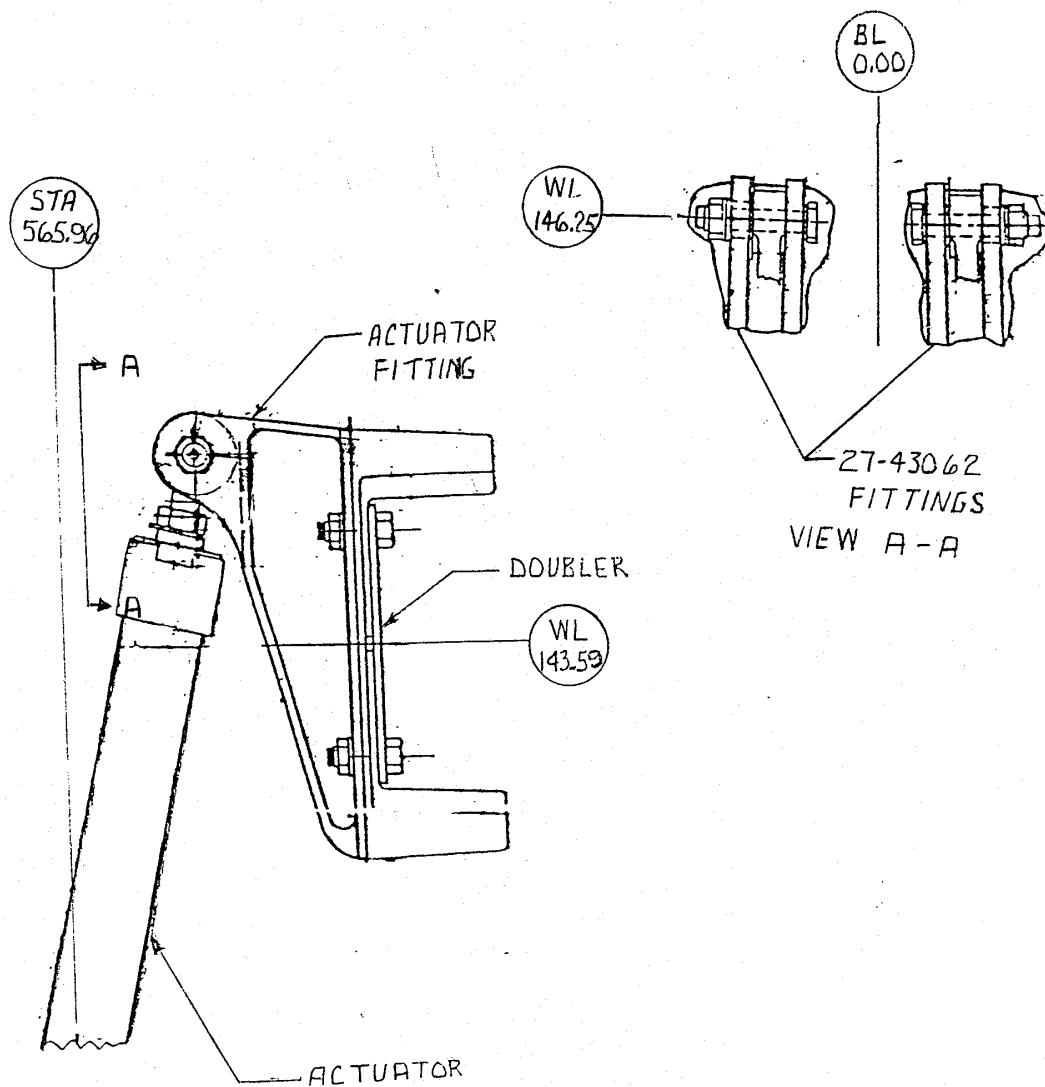
**FIGURE 6-28 H2 – SA226 AND SA227 HORIZONTAL STABILIZER PITCH TRIM ACTUATOR FITTINGS**

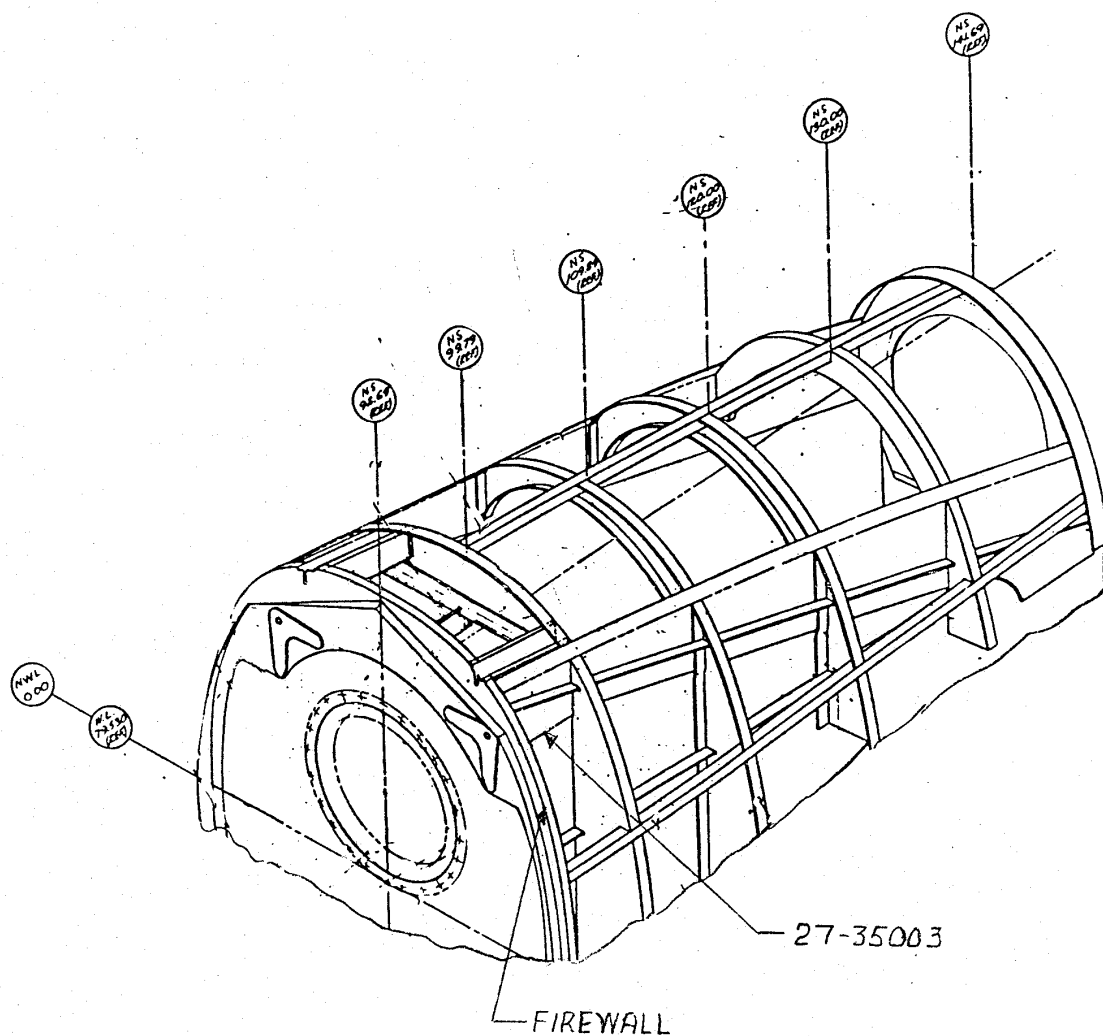
NACELLE UPPER LONGERON  
AT FIREWALL

**FIGURE 6-29 N1 - SA226 AND SA227 NACELLE UPPER  
LONGERON AT THE FIREWALL**

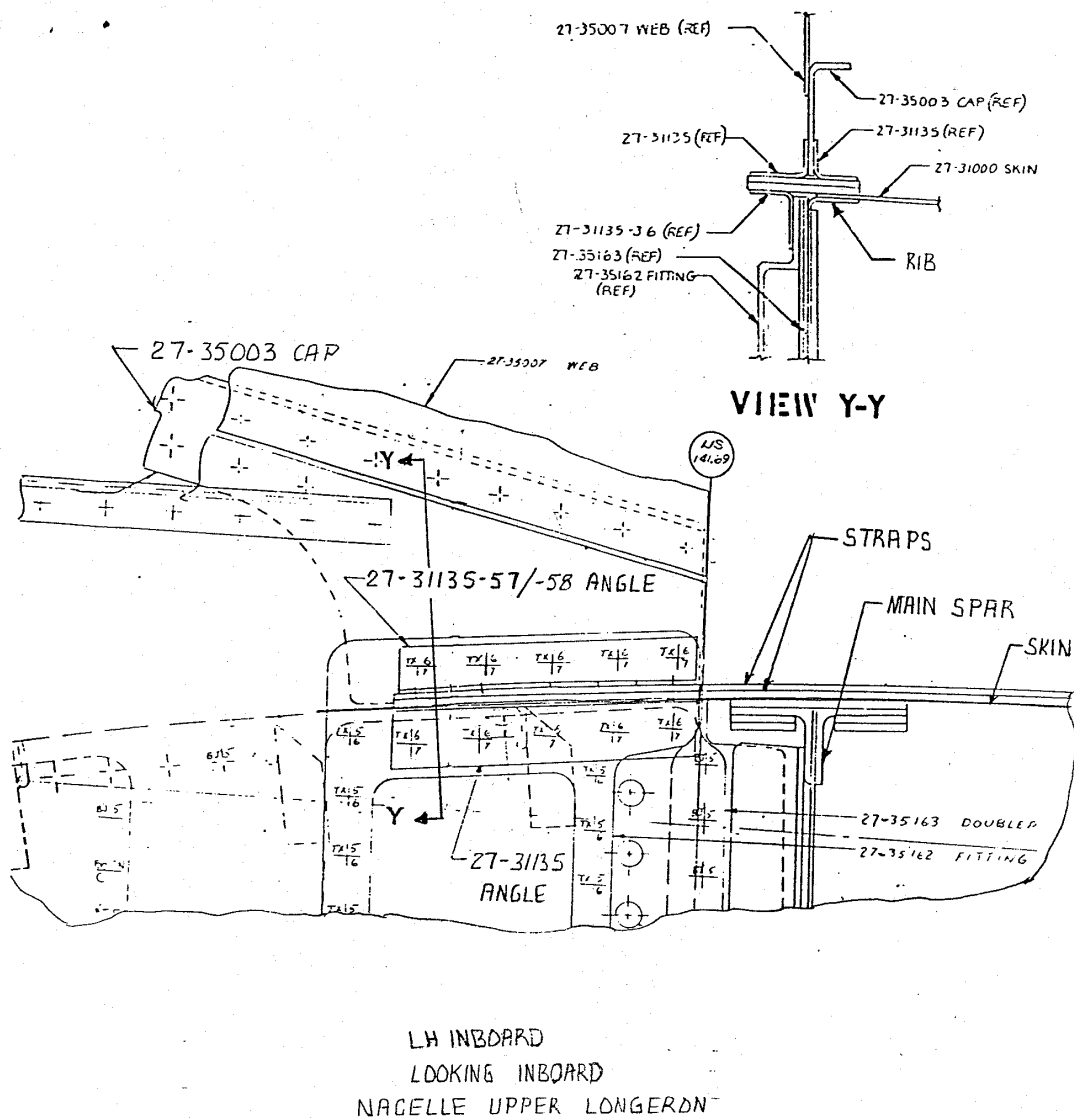
**FIGURE 6-30 N2 AND N3 – SA226 AND SA227 NACELLE UPPER LONGERON AT THE ATTACHMENT TO THE WING RIB**

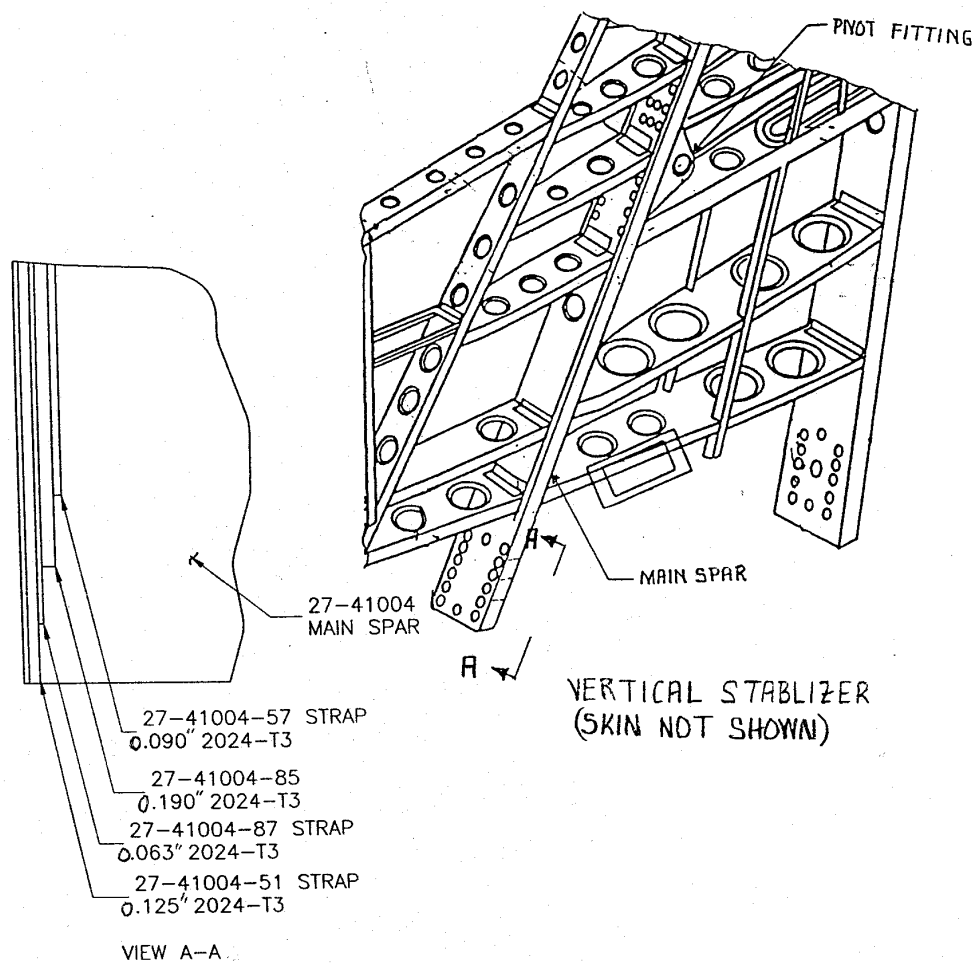
**FIGURE 6-31 V1 – SA226 AND SA227 VERTICAL FIN MAIN SPAR  
CAP STRIPS**
